**1120 Brabec St**

**RE: Pittsburgh, PA 15212**

**Inspection #: 527-022018-1696**

### HOME INSPECTION REPORT

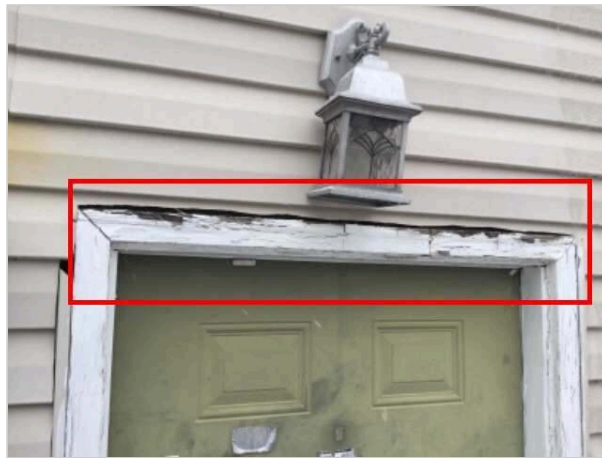
Rotted wood was noted on many areas of the exterior of the home . The areas should be repaired and sealed by a qualified contractor.

Rotted wood example.

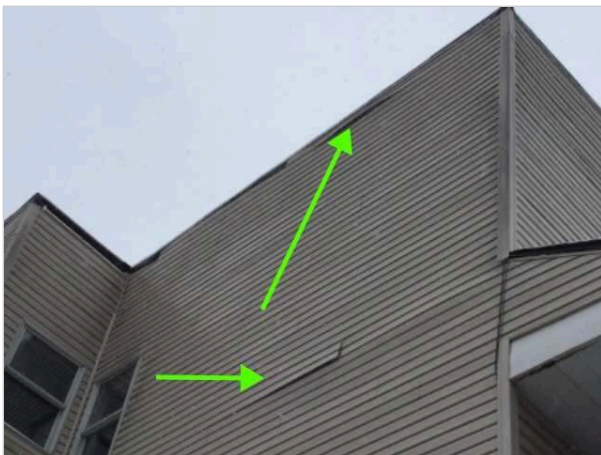
Loose siding was noted on the back and right side of the home. The siding should be reattached.

Loose siding.

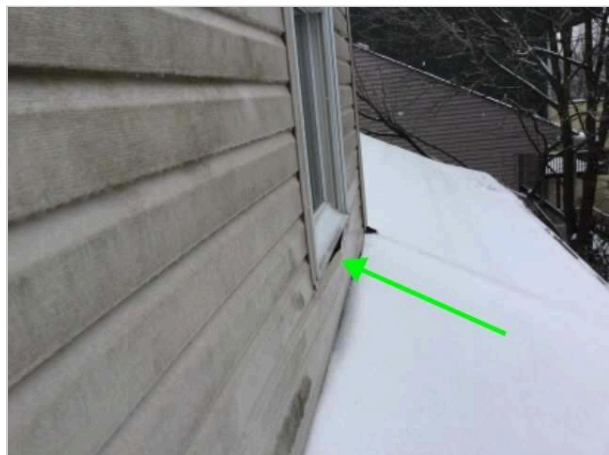
Loose siding on back

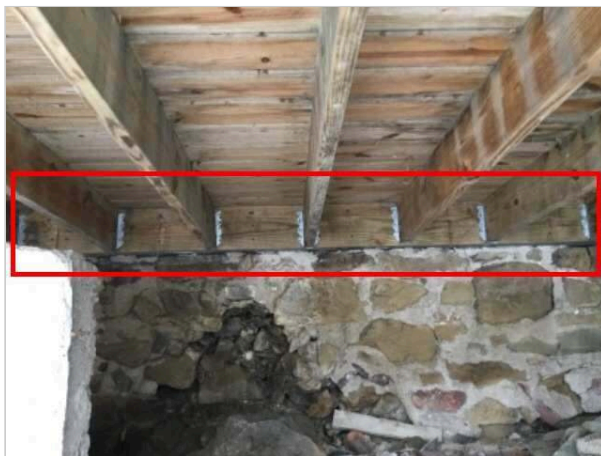
The ledger board for the deck is nailed to the main structure of the home rather than bolted. Generally accepted deck construction techniques require the deck to be bolted to the main structure of the home at regular intervals. Consult with a qualified contractor to anchor the deck to the home with bolts.

Deck ledger not bolted.

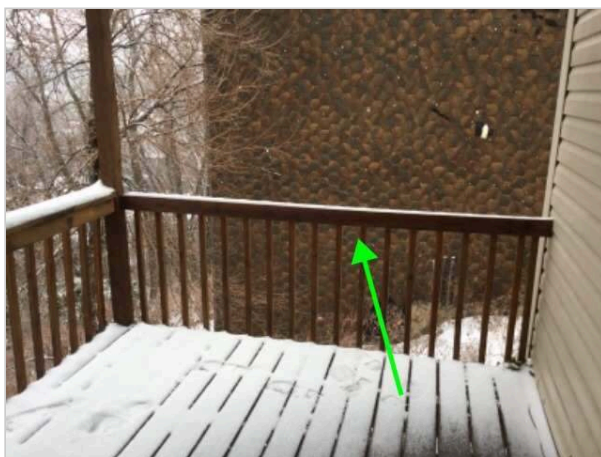
The deck rail is loose. The rail should be secured for safety by a qualified contractor.

Loose deck rail

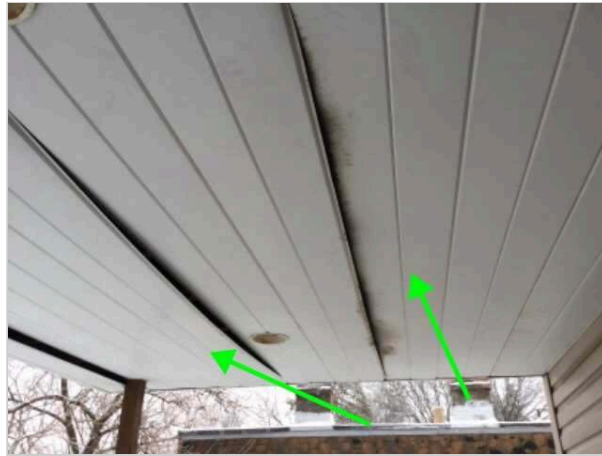
Loose soffit was noted on the deck roof. Consult with a qualified contractor for repair.

Loose soffit

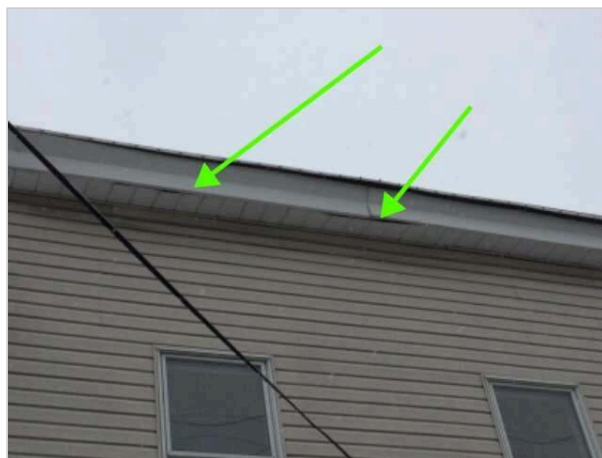
Loose soffit was noted on the front. Consult with a qualified contractor for repair.

Loose soffit.

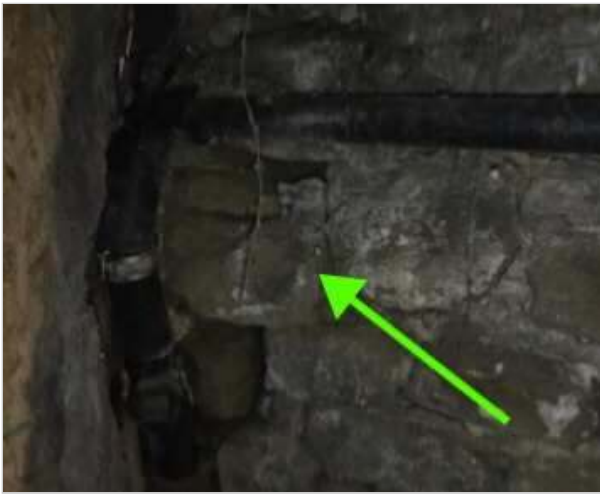
There were significant horizontal and vertical earth-pressure type cracks observed on the front and rear foundation wall at the time of the inspection. There was also an inward bulge observed on the front and rear foundation wall. The wall was not considered stable at the time of the inspection. Consult with a company specializing in foundation repair for further evaluation and recommendations.. This condition is most often associated with soil and / or water pressures. The displacement occurs incrementally as the wall yields to horizontal earth pressure. Surface grading around the foundation is inadequate. Proper grading should be maintained to prevent foundation damage and water penetration.

Front foundation wall in general state of disrepair.

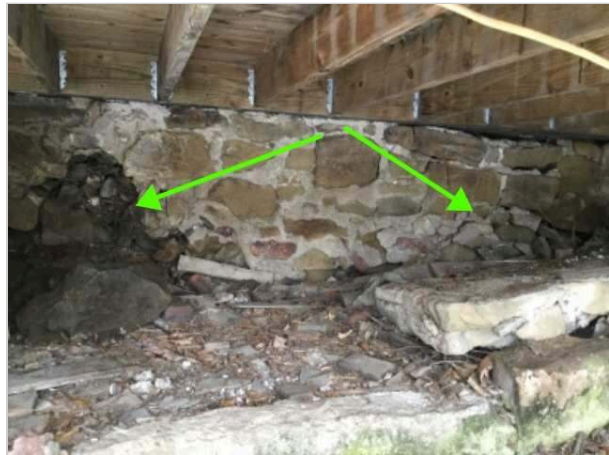
Rear foundation wall in general state of disrepair.

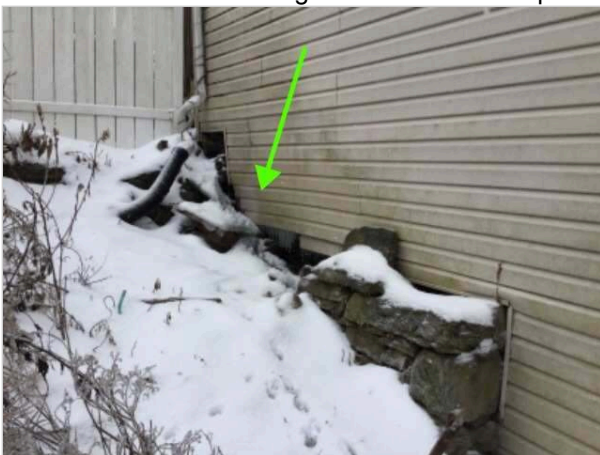
Front right foundation bowed inward.

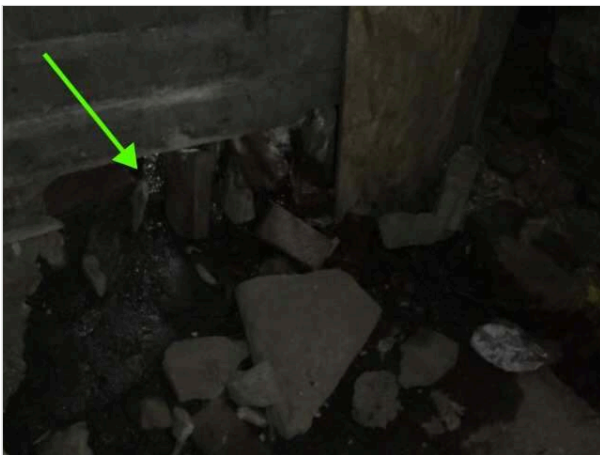
There were signs of moisture on the front, left and right basement walls. The area was not dry at the time of the inspection. Dampness on basement walls is not always a sign of water intrusion. The dampness can be the result of warm humid air making contact with cool walls. In many cases the humid air condenses on the wall and forms a layer of moisture. It is important to assess whether moisture on the basement walls is the result of water intrusion or condensation. In this case the condition appears to be the result of water intrusion. The exterior grading in the affected area is inadequate. Many water intrusion problems can be controlled by improving the drainage on the exterior of the home. It is important that all roof drainage and surface water is directed away from the foundation. Consult with a qualified contractor for further evaluation and recommendations.

Water intrusion- right front.

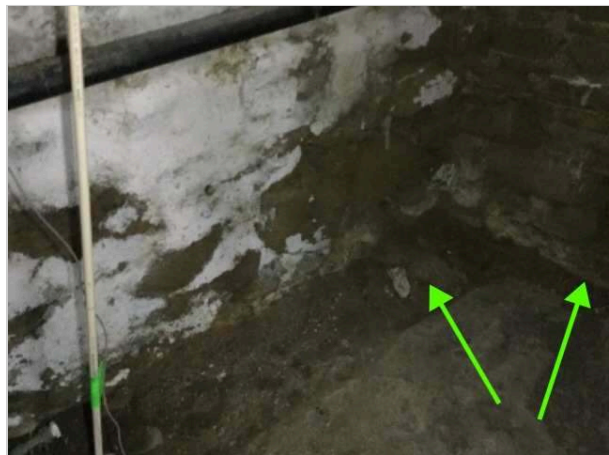
Basement moisture left front

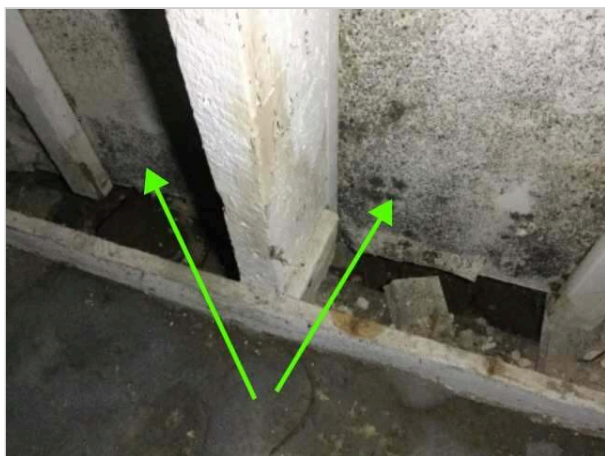
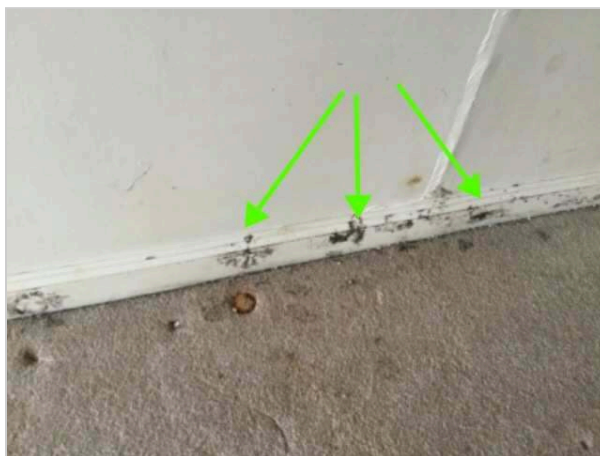
A substance with the characteristics of mold is visible in one or more areas of the property. The EPA (<http://www.epa.gov/mold/moldresources.html>) advises consumers that areas less than ten square feet of coverage can usually be controlled using readily available household products. In the event the substance cannot be controlled, a certified mold testing and remediation firm should be contacted for a recommended course of action.

Basement mold like substance example.

Mold like substance basement

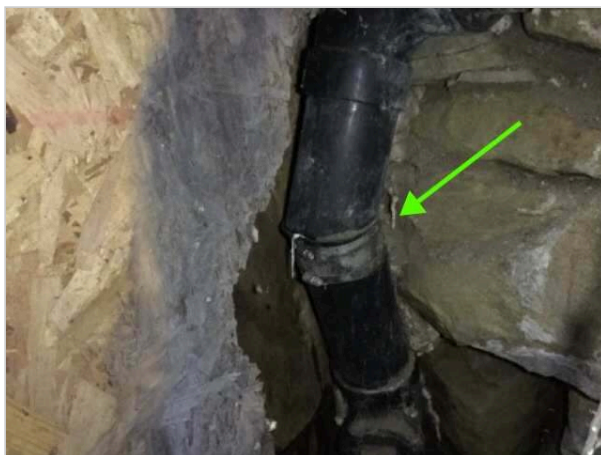
The main drain stack near the front basement wall was pushed inward due to the foundation movement. Consult with a qualified plumber for repair.

Drain stack pushed by foundation.

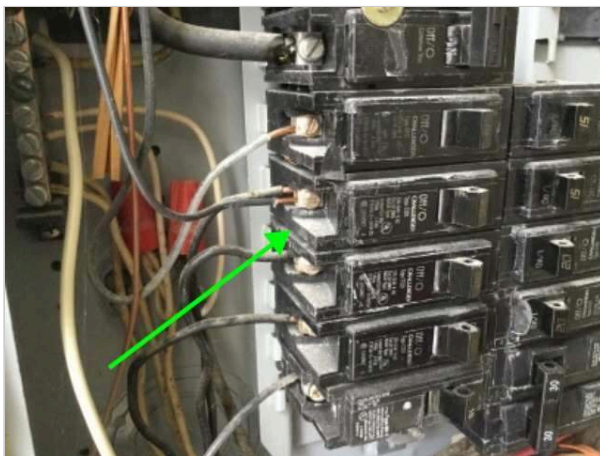
The circuit in position 3 of the service panel is double tapped. This means that more than one wire is attached to the overload protection device (fuse or circuit breaker). Double tapping can lead to nuisance tripping and should be avoided. Nuisance tripping occurs when the total amperage of the wires attached to the breaker exceed the rating of the breaker. For instance, if the double lugged breaker has a rating of 15amps and the two wires attached are each drawing

10 amps, the breaker would trip. Neither one of the two wires is overloaded, but the total amperage flowing through the breaker is 20 amps. The breaker will trip even though no single wire is overloaded. Hence, the term, "nuisance tripping". Each circuit in the main service panel should have just one wire / circuit attached to the overload protection device. Consult with a qualified electrician for repair.

Double tapped circuit

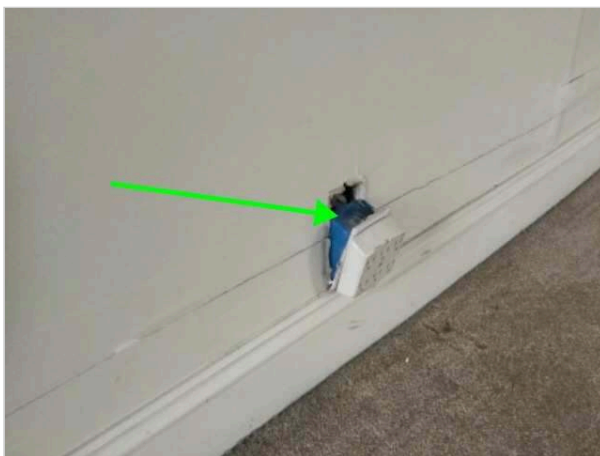
A loose outlet was noted in the rear bedroom. This could be a shock hazard due to exposed electrical contacts. The affected outlet(s) should be secured by a qualified contractor.

Loose outlet

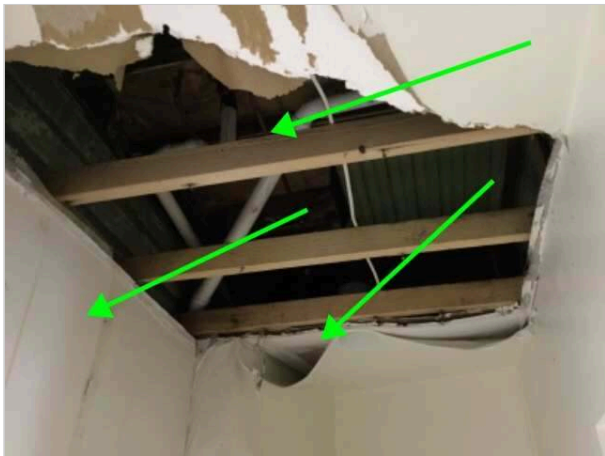
Water marks with significant surface damage was noted on the walls and ceilings in the living room. The water marks appeared to be the result of previous leaks. Consult with a qualified contractor for evaluation and repairs as required.

Ceiling and wall damage from pipes leaking

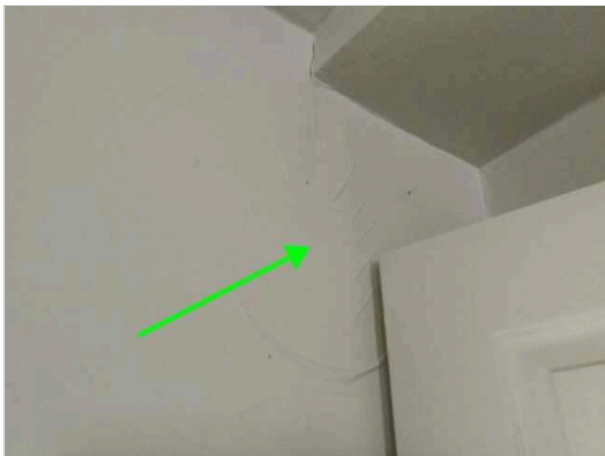
Cracked or bubbling paint was noted on the walls in the living room. This condition appeared to be caused by water. There was no evidence of an active leak at the time of the inspection. Any damaged areas should be scraped, repaired, leveled and primed prior to applying a finish coat of paint.

Bubbly paint

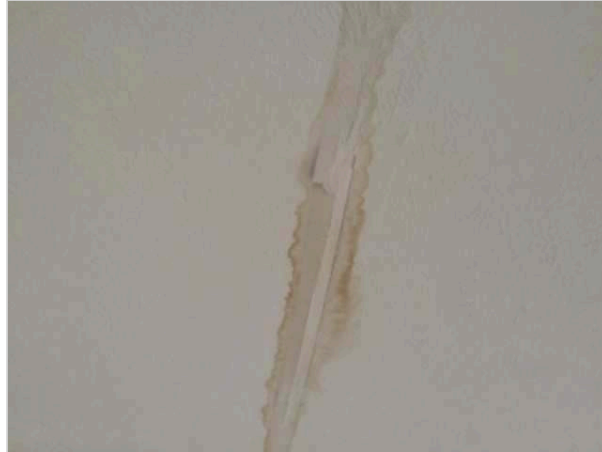
Water marks with minor surface damage was noted on the ceilings in the front and rear bedroom The water marks appeared to be the result of previous leaks. No immediate action is required. The affected area (s) should be monitored for evidence of new leaks. Consult with a qualified contractor for repair if required.

Watermark from previous leak

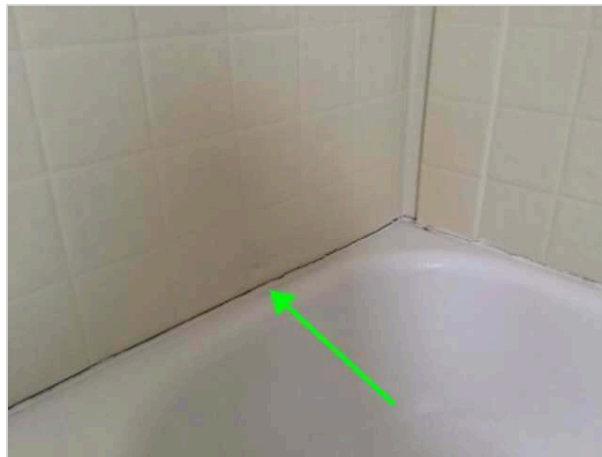
Failure to keep walls sealed can cause deterioration and extensive moisture damage including mold growth to the interior walls, which is not always visible at the time of the inspection. Some of the caulk was missing from around the tub . These areas should be re-caulked to help prevent moisture penetration.

Missing caulk

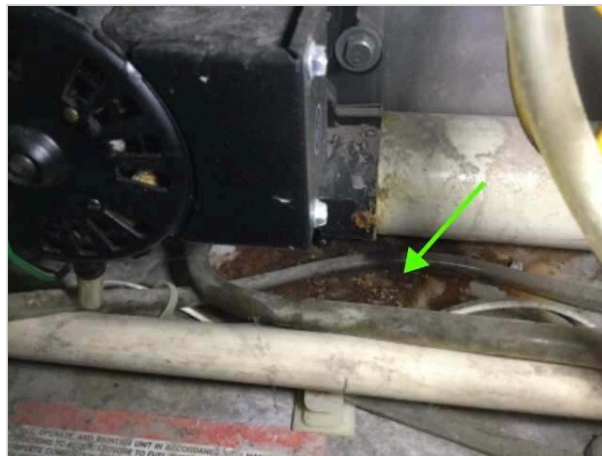
Evidence of water was noted inside the furnace compartment. The condition is most likely caused by a condensate leak in the furnace and/or air conditioning condensate drain lines. The water can also be caused by a leaking humidifier if one is installed. Water inside the furnace compartment can damage the furnace cabinet or other operational components and should be repaired. The furnace compartment was dry at the time of the inspection. Consult with a qualified heating contractor to determine the source of the water and correct the issue. Please also note that due to the seasonal use of heating and air conditioning systems, wet and dry conditions can change based on whether the inspection is performed during the heating or cooling season. The observation at the time of the inspection can be limited to seasonal conditions.

Evidence of previous leaks.

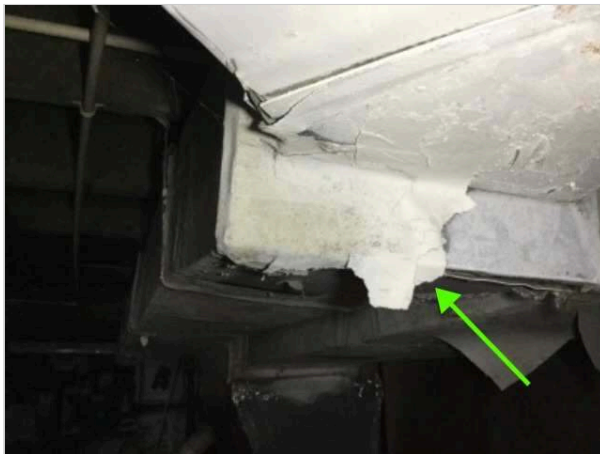
The air ducts in the basement were covered with a material that has the characteristics of asbestos. The material did appear to be damaged or deteriorating at the time of the inspection. It is advisable to avoid disturbing the substance prior to any testing. The only way to confirm the contents of the material is to have a sample tested by a qualified laboratory. If the substance is of any concern, a qualified asbestos testing firm should be contacted.

Possible asbestos material on ductwork.
