# 1120 Brabec St. Application Instructions

*HOME INSPECTION REPORT*

SUMMARY: The purpose of this summary is to provide a "quick view" of the results of the home inspection. Please be sure to read the full body of the inspection report, as it contains much more detail about your new home. Any recommendations for additional evaluation must be performed prior to the conclusion of the inspection contingency period. The following is a summary of the inspection performed at 1120 Brabec St, Pittsburgh, PA 15212:

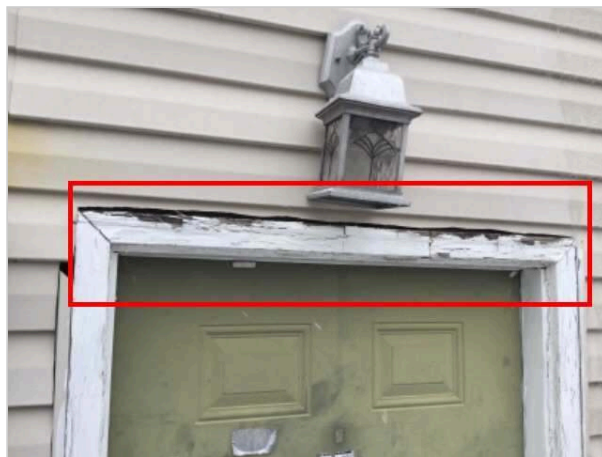
Rotted wood was noted on many areas of the exterior of the home . The areas should be repaired and sealed by a qualified contractor.

Rotted wood example.

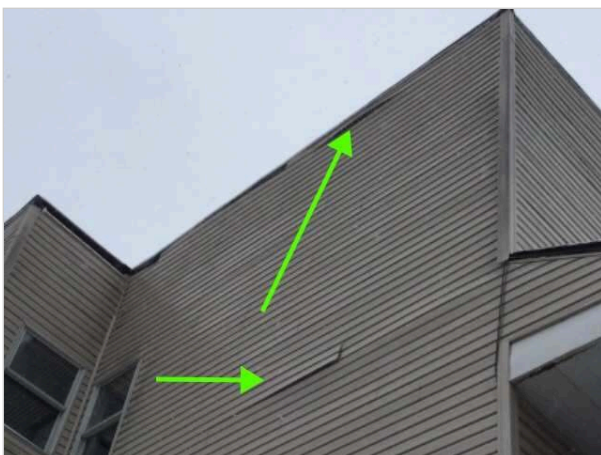
Loose siding was noted on the back and right side of the home. The siding should be reattached.

Loose siding.

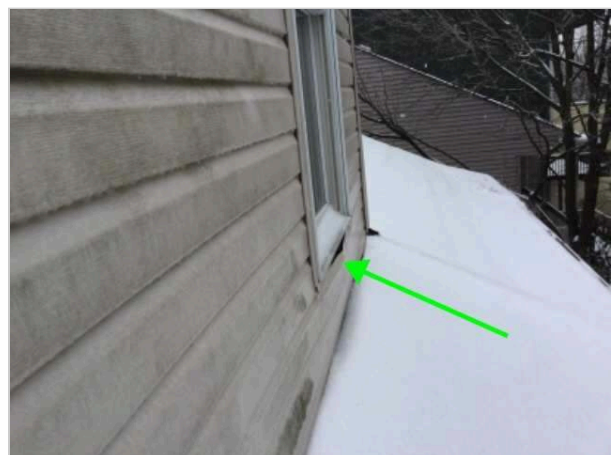
Loose siding on back

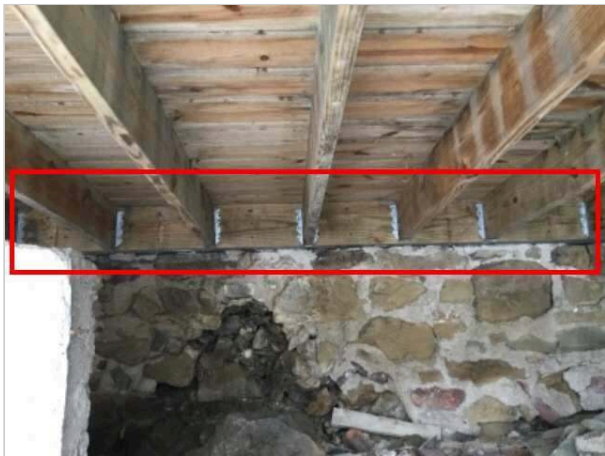
The ledger board for the deck is nailed to the main structure of the home rather than bolted. Generally accepted deck construction techniques require the deck to be bolted to the main structure of the home at regular intervals. Consult with a qualified contractor to anchor the deck to the home with bolts.

Deck ledger not bolted.

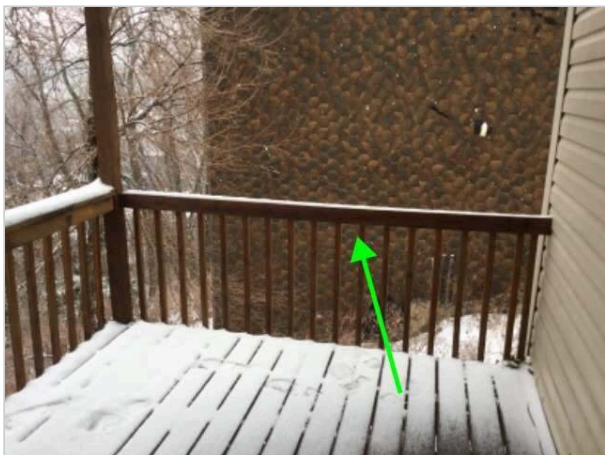
The deck rail is loose. The rail should be secured for safety by a qualified contractor.

Loose deck rail

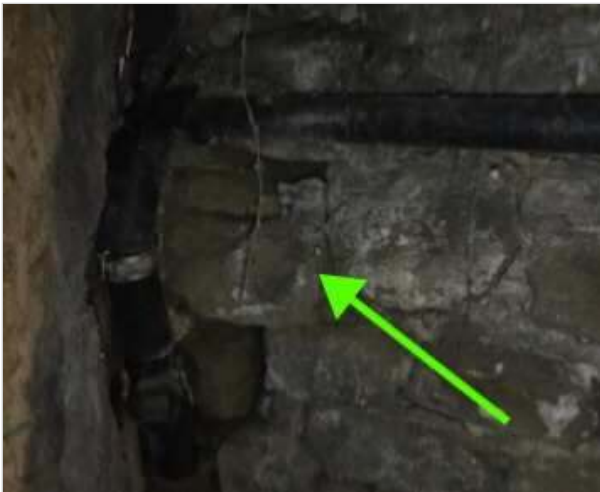
There were significant horizontal and vertical earth-pressure type cracks observed on the front and rear foundation wall at the time of the inspection. There was also an inward bulge observed on the front and rear foundation wall. The wall was not considered stable at the time of the inspection. Consult with a company specializing in foundation repair for further evaluation and recommendations.. This condition is most often associated with soil and / or water pressures. The displacement occurs incrementally as the wall yields to horizontal earth pressure. Surface grading around the foundation is inadequate. Proper grading should be maintained to prevent foundation damage and water penetration.

Front foundation wall in general state of disrepair.

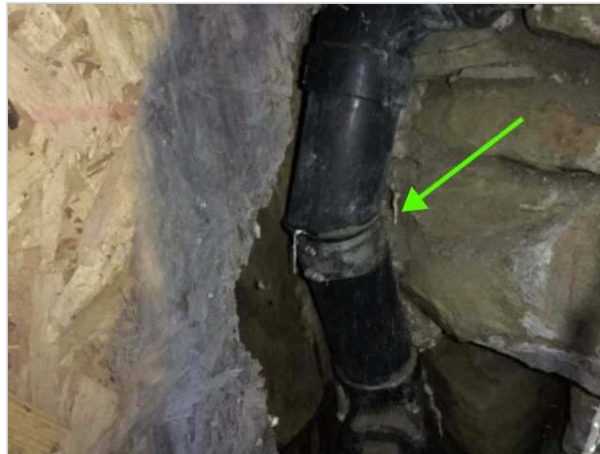
The main drain stack near the front basement wall was pushed inward due to the foundation movement. Consult with a qualified plumber for repair.

Drain stack pushed by foundation.

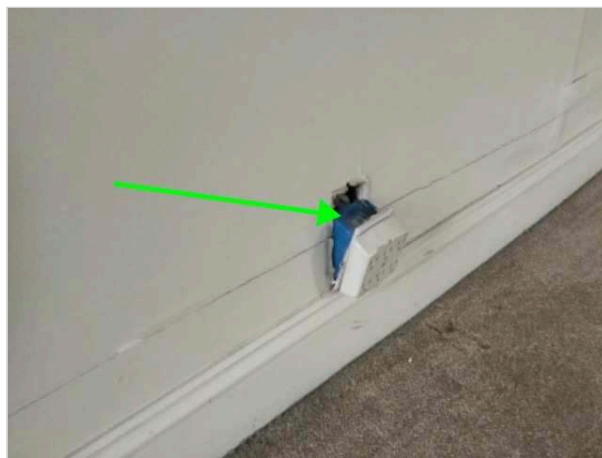
A loose outlet was noted in the rear bedroom. This could be a shock hazard due to exposed electrical contacts. The affected outlet(s) should be secured by a qualified contractor.

Loose outlet

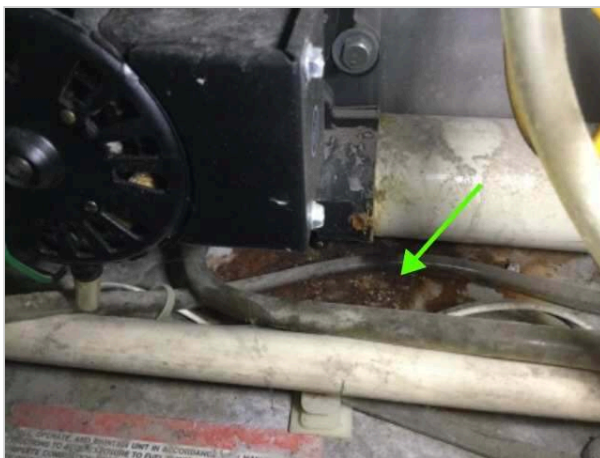
Evidence of water was noted inside the furnace compartment. The condition is most likely caused by a condensate leak in the furnace and/or air conditioning condensate drain lines. The water can also be caused by a leaking humidifier if one is installed. Water inside the furnace compartment can damage the furnace cabinet or other operational components and should be repaired. The furnace compartment was dry at the time of the inspection. Consult with a qualified heating contractor to determine the source of the water and correct the issue. Please also note that due to the seasonal use of heating and air conditioning systems, wet and dry conditions can change based on whether the inspection is performed during the heating or cooling season. The observation at the time of the inspection can be limited to seasonal conditions.

Evidence of previous leaks.

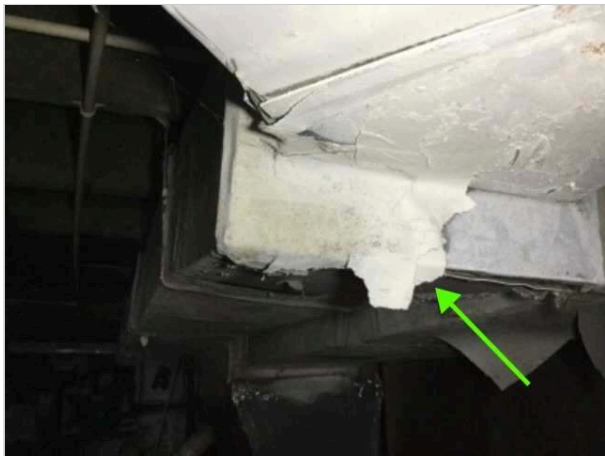
The air ducts in the basement were covered with a material that has the characteristics of asbestos. The material did appear to be damaged or deteriorating at the time of the inspection. It is advisable to avoid disturbing the substance prior to any testing. The only way to confirm the contents of the material is to have a sample tested by a qualified laboratory. If the substance is of any concern, a qualified asbestos testing firm should be contacted.

Possible asbestos material on ductwork.
